**Subject: Removal Action Report – Revision 1
Nelson Knitting Site – RV
Rockford, Winnebago County, Illinois
EPA Contract Number: 68HE0519D0005
Task Order – Task Order Line-Item Number (TO-TOLIN): F0032-0001DL101
Document Tracking Number: 1588a**

REMOVAL ACTION REPORT

NELSON KNITTING SITE – RV

Revision 1
April 25, 2023

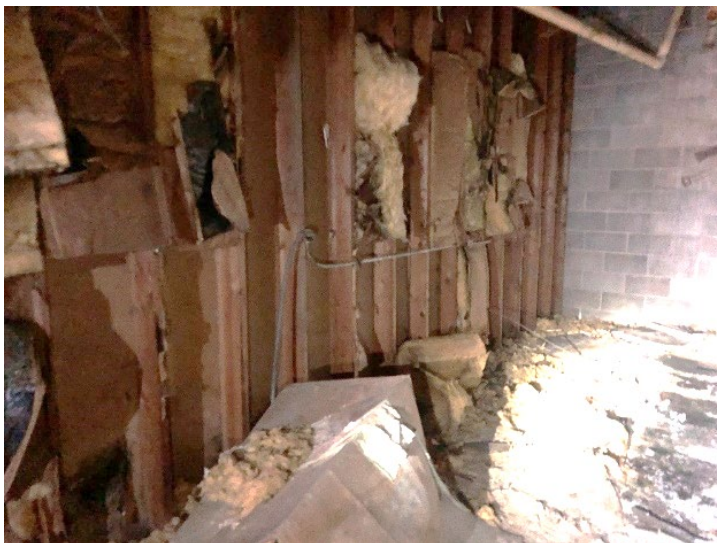
Photograph 9

Description: Large amounts of asbestos-containing material (ACM) on the main floor of the building

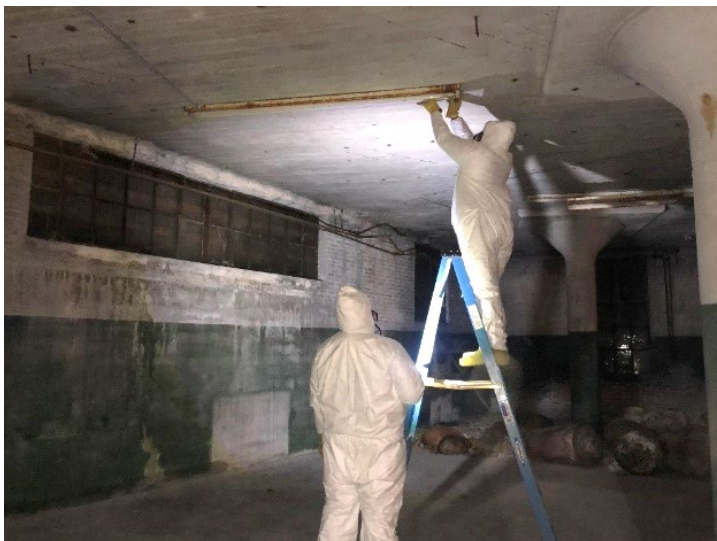
Photograph 11

Description: EQM removing polychlorinated biphenyl (PCB) ballasts and fluorescent tube lamps on the basement level of the building

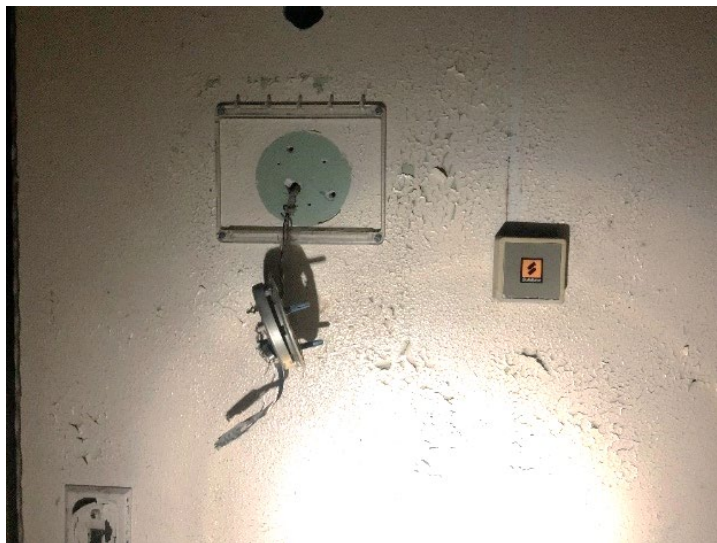
Photograph 12

Description: Mercury-containing light switch in the office on the northern side of the main floor of the building

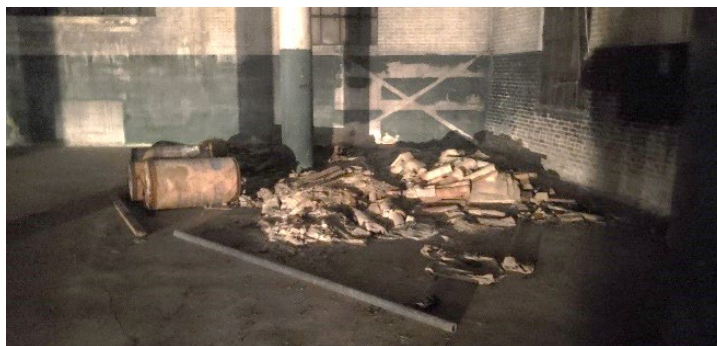
Photograph 154

Description: Large pile of ACM on the basement level of the building

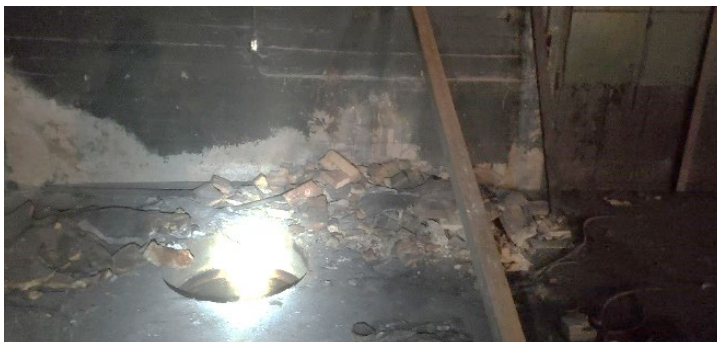
Photograph 23

Description: Boiler room initial conditions; hazard hole in the northwestern corner of the room

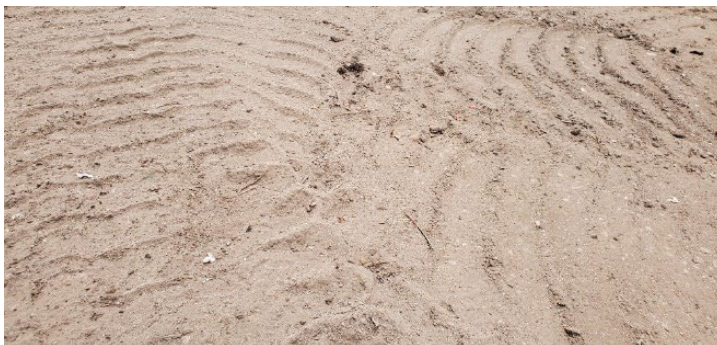
Photograph 32

- On February 14, 2023, there were five exceedances between the personnel entrance and the eastern bay door stations; these were caused by high winds and exhaust from the skid-steer, both of which kicked up the fine silt that lined the alley on the eastern side of the building.

Description: Fine silty dust lining the alleyway, a likely cause for elevated particulate readings

To lessen off-site particulate migration and to reduce the number of exceedances, EQM used rainwater collected with the Dingo TX-1000 to dampen ACM before transferring it to a lined roll-off box. START noted that exceedances were most commonly caused by high-wind speeds and the exhaust of EQM's skid-steer, which was kicking up dust and fine silt around the site.

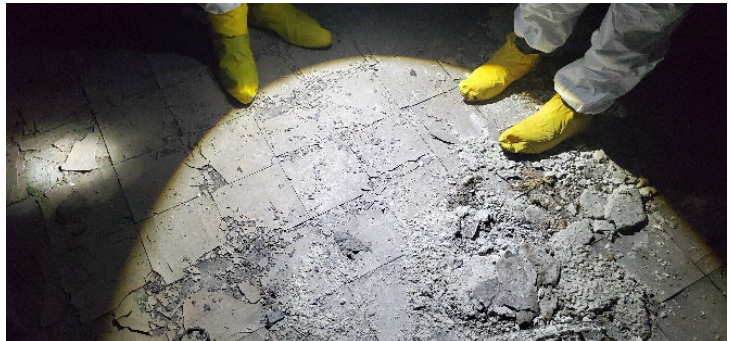
Photograph 46

Description: Additional ACM found in the tile on the stairwells

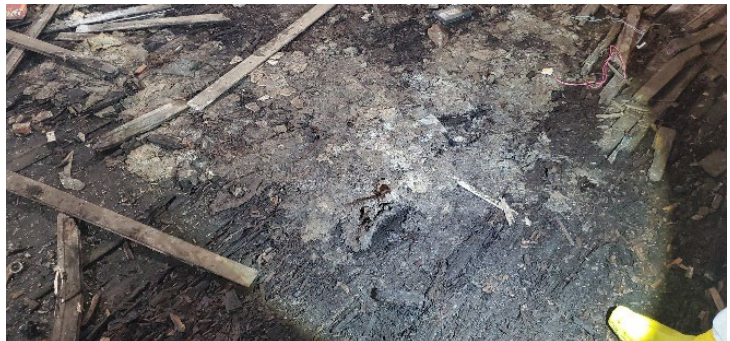
Photograph 47

Description: Additional ACM found on the main floor of the building
